**AN HISTORIC RESOURCE EVALUATION AND
SECRETARY OF INTERIOR'S STANDARDS
FOR THE TREATMENT OF HISTORIC
PROPERTIES REVIEW OF THE PROPERTY
LOCATED AT 3 NORTH STREET,
HEALDSBURG, SONOMA COUNTY**

**February 12, 2018
(Final December 13, 2021)**

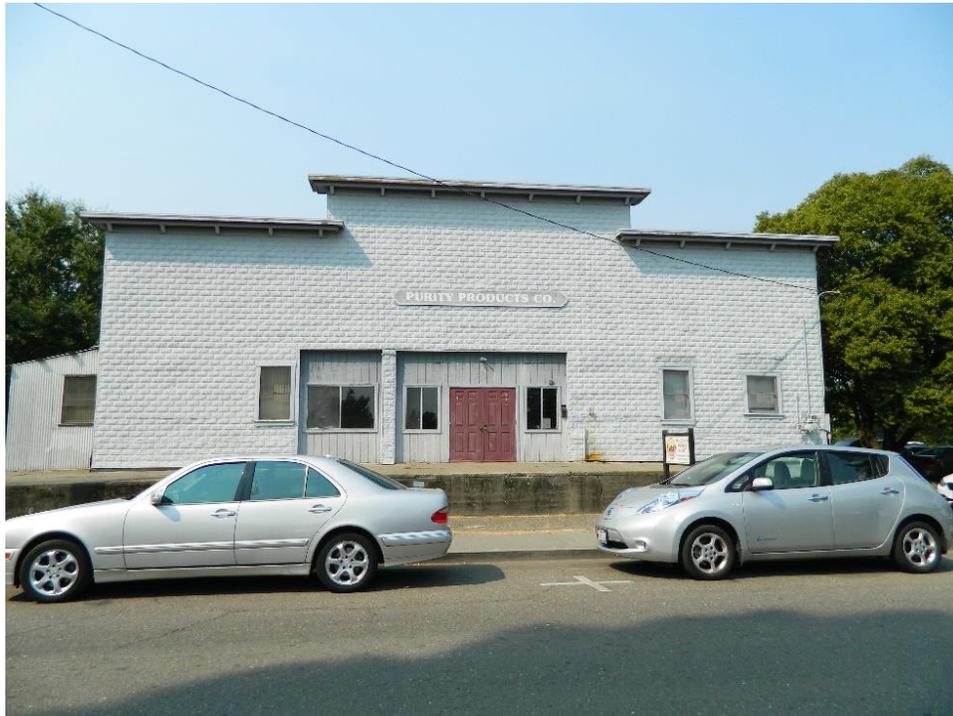
Figure 13. Photograph showing the primary façade, facing north.

The primary façade (south elevation) consists of a stepped parapet and is clad in decorative stamped metal sheets that were popular in the 1920s for its resistance to corrosion. The primary façade consists of a raised concrete loading dock and a ramp that faces east. The ramp was initially utilized for loading and unloading through wide barn-style doors (Figure 13). However, the original doorway was modified in the 1950s or 1960s that was enclosed with vertical wood paneling, and standard-sized double-entry doors, as well as three metal slider windows. There are three window openings along this façade and four original double-hung wood windows and wood trim along the primary façade that appear to be in fair condition (Figure 14). The stepped parapet is constructed of wood and consists of an overhanging eave and a decorative wood cornice and a wide wood fascia board (Figure 15). There is also a metal sign, which is not original to the building, along the center of the primary façade that states "Purity Products Co." Although the stamped metal is original, the original painted signage that once showed Cerri Brothers, Rosenberg Brothers, and Del Monte had been painted over. Changes to the primary façade, which occurred in the 1960s (and possibly in the 1970s), including several window openings, changes to the front entry, and the infill of the front entry opening, are incompatible with the original design.

Due to severe deterioration and corrosion in areas of the stamped metal cladding (primary façade) and corrugated metal (side and rear elevations), the exterior cladding along all four elevations will be replaced in-kind. The stamped metal cladding will be replaced with clear anodized metal mesh siding, which is a “like” material, and the corrugated metal along the side and rear elevations will be

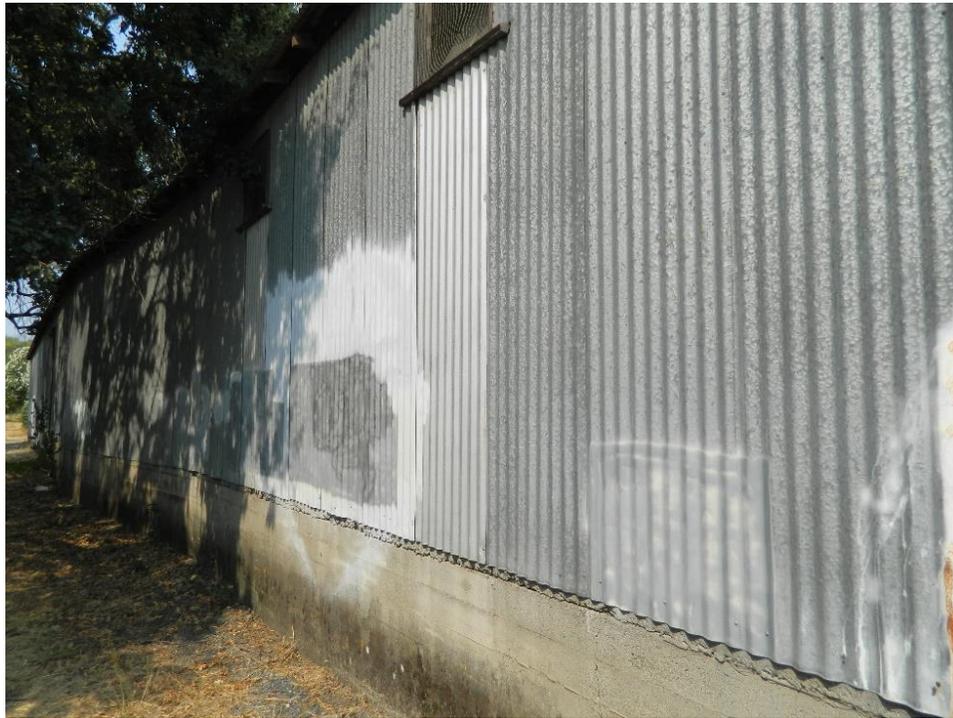
Figure 16. Photograph showing the west elevation, facing north.

The west elevation consists of a shed addition, which may have consisted of some open bays at one time for loading when the building was a fruit packing warehouse. The west elevation is clad in panels of sheet metal (Figure 16 and Figure 17). There are also several double-hung wood windows along the upper portion of the walls near the roof overhang of the shed addition. The windows are wood and appear to be original to the building, or at least over 50 years in age. The shed roof consists of exposed rafters and a corrugated sheet metal roof. The concrete loading dock also extends around a portion of the west façade, and there are several doors that appear to be original entryways to the building. However, it is unclear if the doors are original.

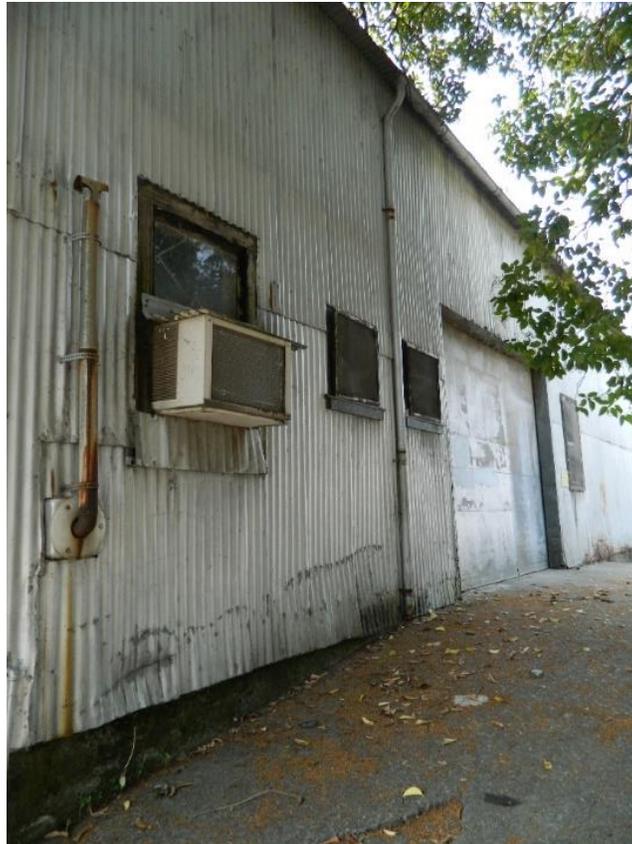
Figure 18. Photograph showing the east elevation, facing north.

The east elevation is clad in corrugated sheet metal and two large entry bays with barn-style sliding doors that are clad in corrugated sheet metal (Figure 18 and Figure 19). There are two doors, three double-hung wood windows, and two smaller windows that may be fixed but are difficult to see. There is a shed addition that is clad in corrugated sheet metal with a metal roof and exposed rafters. There is a loading dock and ramp along this elevation and the parking lot is adjacent and east of the building. This east elevation is in fair to poor condition.

Due to severe deterioration and corrosion of the stamped metal cladding (primary façade) and corrugated metal (side and rear elevations), the materials will be removed and replaced in kind with like materials, design, and style utilizing both physical and photographic evidence. In addition, some areas along the west and east elevations where original deteriorated corrugated metal is removed will remain open bays as part of the rehabilitation design.

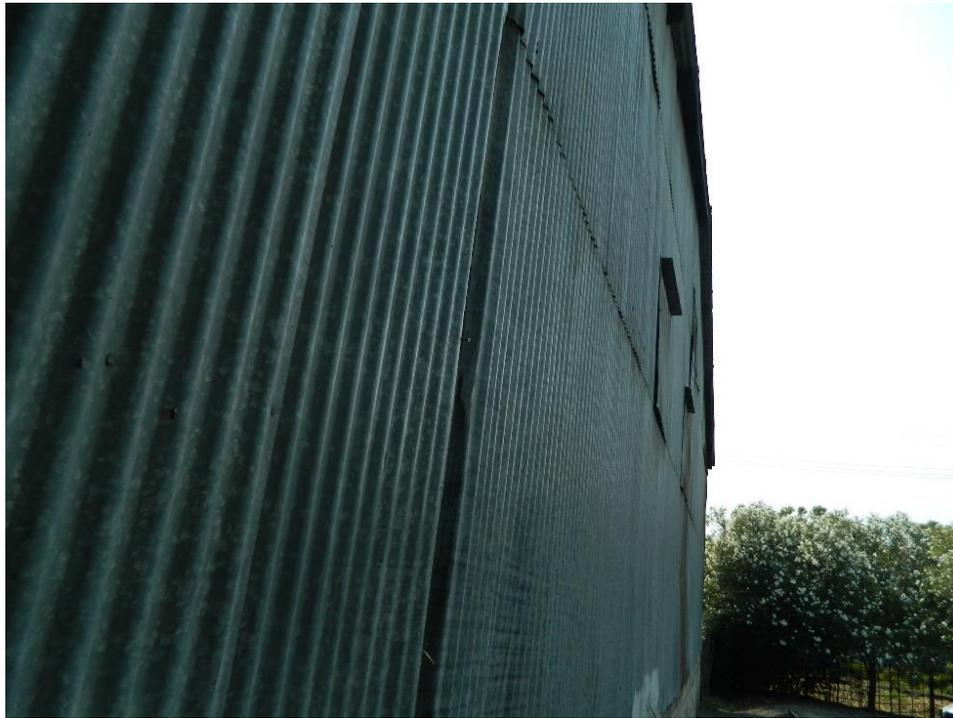
Figure 20. Photograph showing the north elevation, facing west.

The south elevation was not accessible, as there is a fence along the rear (north elevation) of the building that is only accessible through an adjacent property. However, the south elevation was viewed from a section along the east elevation. The north elevation consists of the front-gabled roof and a wall of corrugated sheet metal (Figure 20). There are what appears to be at least two original window openings that have been covered with sheet metal. The north elevation appears to be in fair condition.

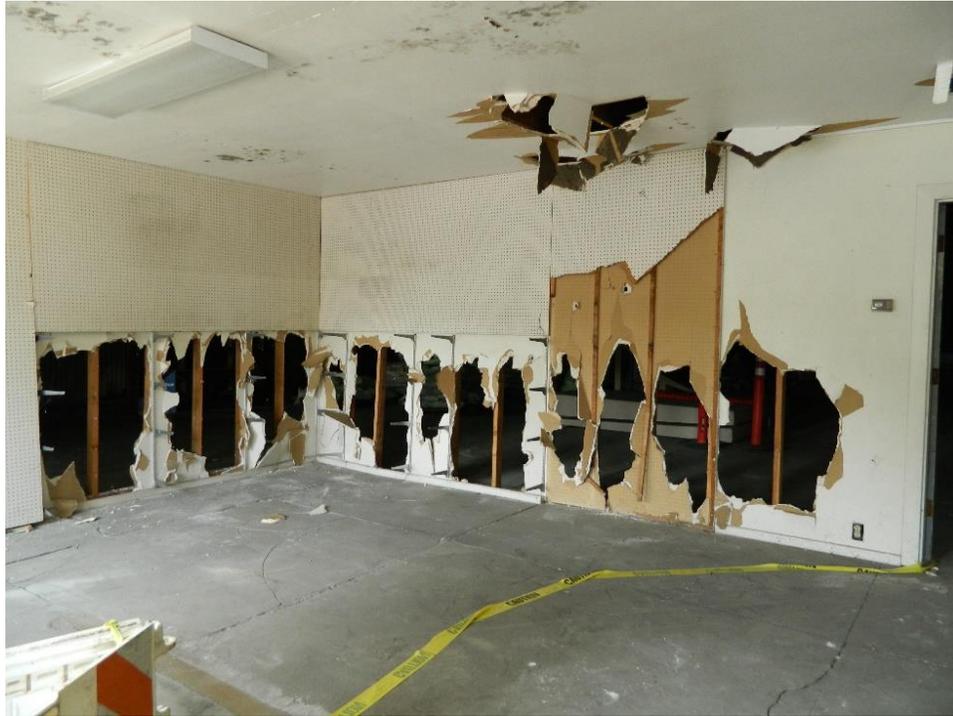
Figure 21. Photograph showing the interior “lobby” portion of the building.

The interior has been modified since its use as a packing warehouse. The enclosed front “lobby” is not original and was likely added when the Purity Company owned the building (Figure 21). The interior also has various spaces within the front portion of the building that have been reconfigured and are not original to the design of the building. There is also a mezzanine above the entrance lobby that is accessible via stairs that are in poor condition. It is unclear if the mezzanine is original to the building but was likely added later. The metal roof framing is exposed within the large open space of the interior where the fruit packing once took place (Figure 22). There are also concrete floors that appear to be original and are in fair condition.

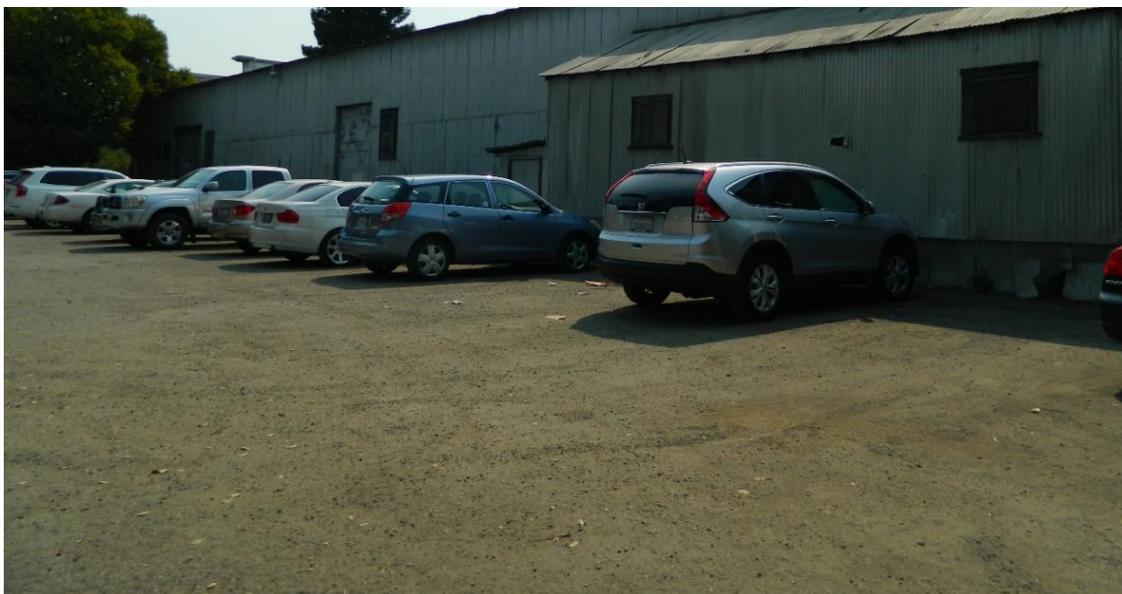
Figure 23. Photograph showing the asphalt parking lot, facing south.

The associated landscape is not associated with any architectural style or landscape architectural design. The associated landscape mainly consists of a gravel and asphalt parking lot (Figure 23) and a right-of-way adjacent and west of the building that consists of the mainline of the NWP; however, the rail spur is no longer present, or at least not visible on the surface. There are various shrubs and trees present, including 11 oak and redwood trees.

The current changes to the associated landscape include the installation of scored, pervious, and permeable concrete and decomposed granite for walkways and the parking area, as well as the planting of approximately 12 trees and 213 shrubs (Figure 28). These changes are minimal and will not affect the integrity of the 1922 building.

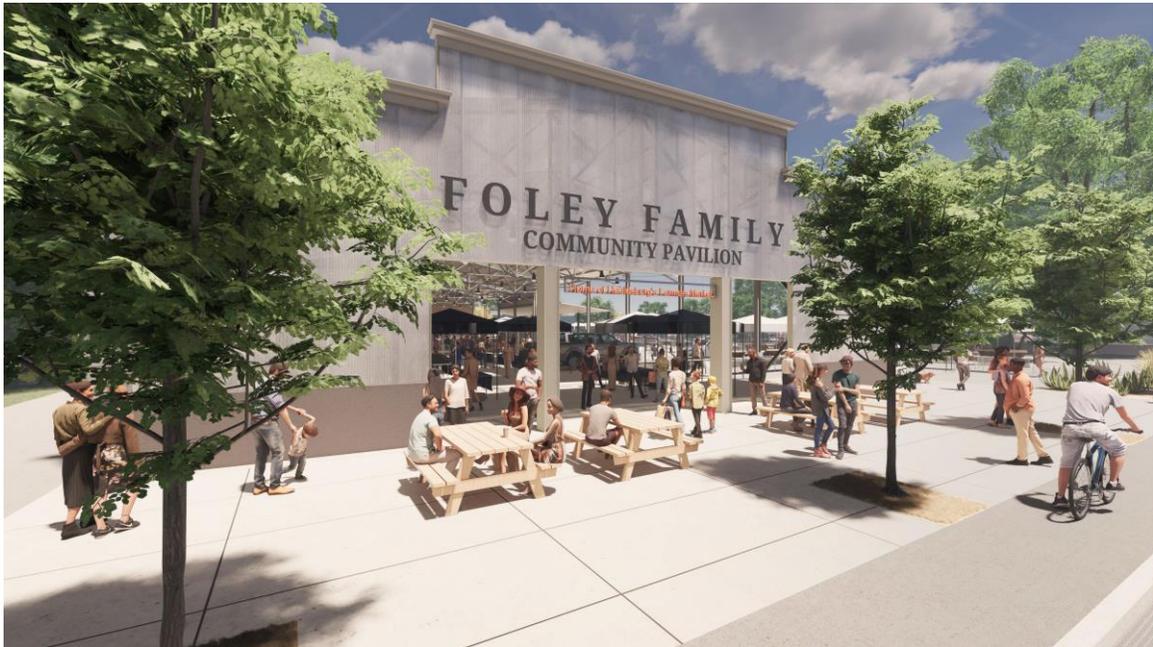
The proposed Project consists of the rehabilitation and reconstruction of the false front façade, including the restoration of the stepped parapet, or based on a condition assessment, may include the reconstruction of the stepped parapet, including the wood cornice and wood frieze based; the removal of the incompatible 1950s/1960s alterations, including the vertical wood paneling, standard sized double-entry doors, and three metal slider windows; and the rehabilitation of the primary façade utilizing the Rehabilitation guidelines to reconstruct the centered front entrance opening, which will be flanked by new side openings that will replace several incompatible windows (Figure 24). Any features that are reconstructed due to their inability or feasibility to be restored will be based on historic photographs and physical evidence. The majority of these changes to the false front façade is considered rehabilitation, but the need to reconstruct instead of restoring the parapet *must* be based on physical evidence that the removal of historic materials is necessary, either due to their inability to be restored or feasibility related to costs. As such, the architectural designs completed by TLCDC Architecture (dated 11/23/2021) include the reconstruction of the parapet with like materials and design.

Figure 24. 3D rendering of the proposed rehabilitation of the false front façade with a stepped parapet (TLCD Architecture, dated 11/23/2021).

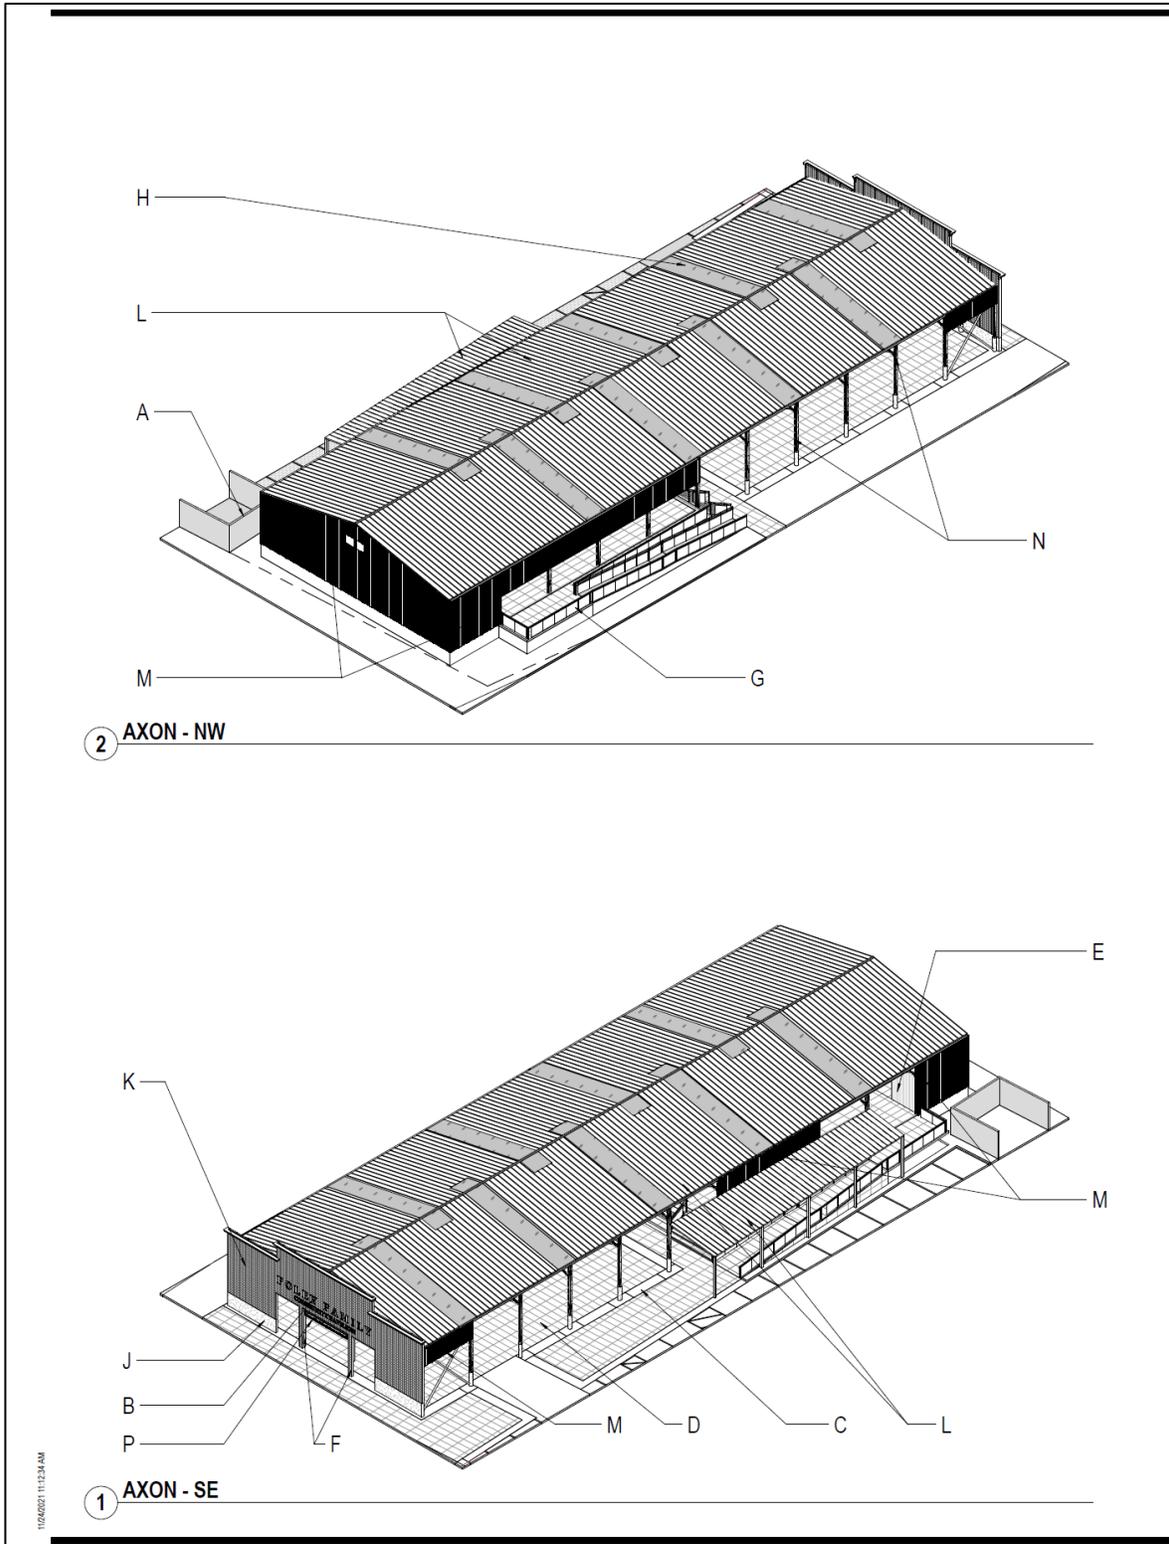
As part of the rehabilitation effort, the proposed Project was designed to provide accessibility in compliance with ADA and the Standards. The design includes reconstructing the current concrete loading docks along east and west elevations and the removal of the loading dock along the primary façade to ensure barrier-free access from the public right-of-way along North Street. In keeping with the Standards, the loading docks on the east and west elevations will be reconstructed utilizing concrete with simple stainless steel and metal mesh railings (**Figure 25**). The shed addition, along the west elevation, which is not original to the 1922 building and is not a character-defining feature, will be removed. Although the Project proposes the removal of the original concrete loading docks, the Standards allow for their reconstruction within the same or similar location for an appropriate new use.

Figure 25. 3D site plans showing the west and east elevations, with the new concrete loading docks, which will also comply with ADA.

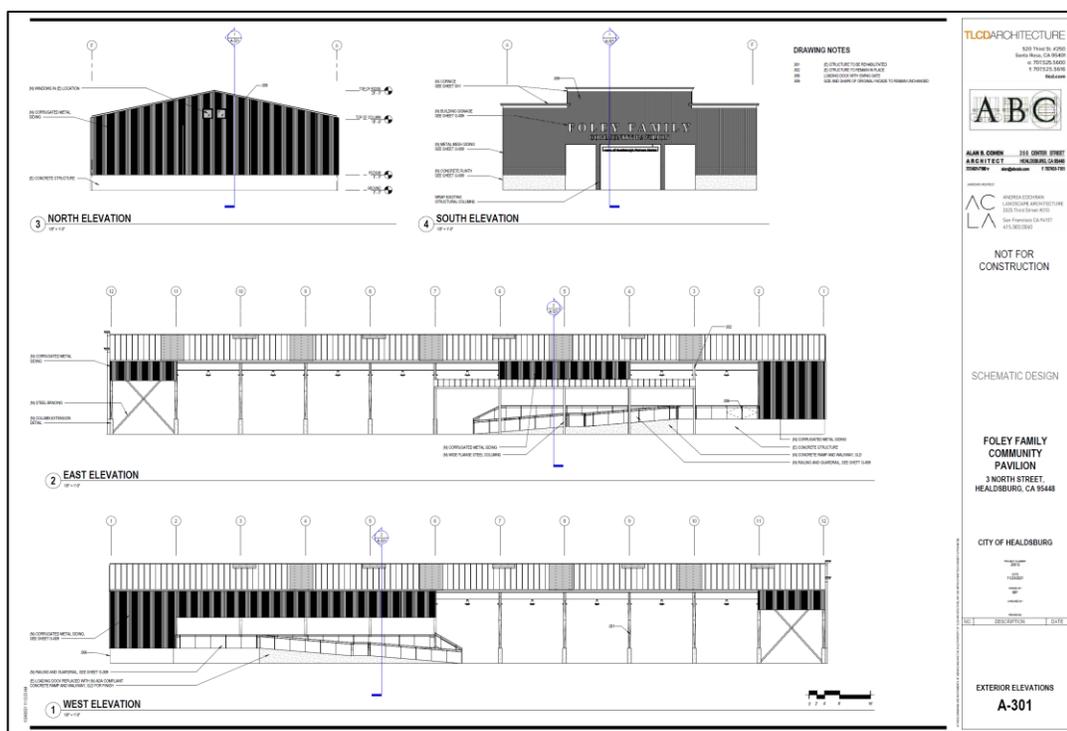
A new standing seam metal roof with skylights will replace the original corrugated metal roof, which is in keeping with the Standards for Rehabilitation.

The exterior alterations as part of the proposed Project are compatible with the massing, size, scale, and architectural features of the 1922 building and protect the historic integrity of the property and its environment to convey its significance under Criterion 1 for its association with early twentieth-century fruit and nut packing industry within the City of Healdsburg.

Figure 27. Drawing showing the proposed exterior elevations of the 1922 building (TCLD Architecture, 11/23/2021).

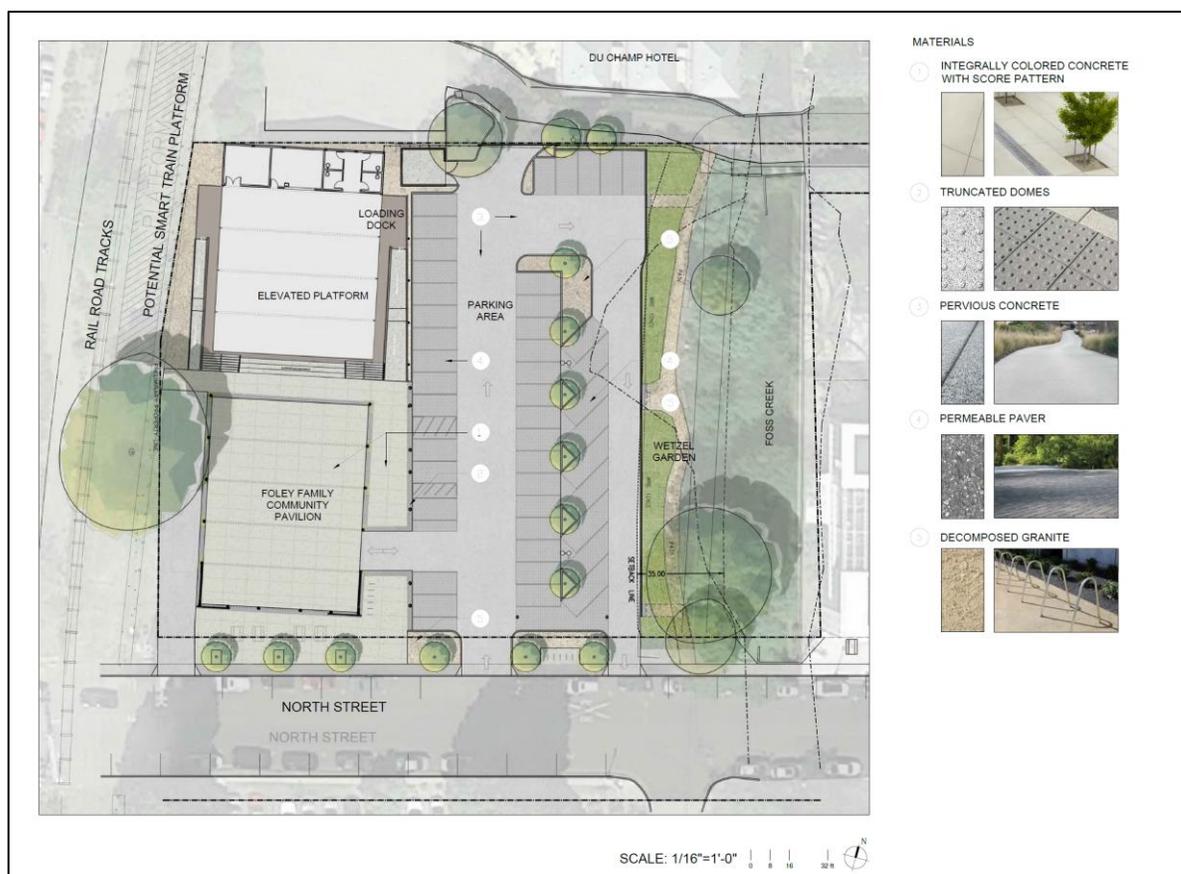
Figure 28. Landscape materials plan (TCLD Architecture, 11/23/2021).

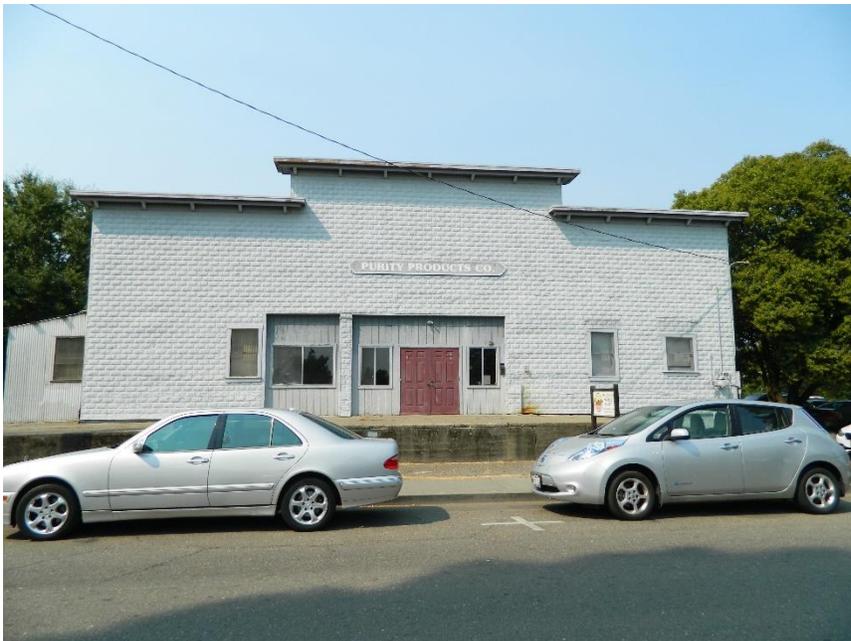
The primary façade consists of a stepped parapet and is clad in decorative stamped metal sheets that was popular in the 1920s for its resistance to corrosion. The primary façade consists of a raised concrete loading dock and a ramp that faces east. The ramp was originally utilized for loading and unloading through wide barn-style doors. However, the original doorway was modified in the 1960s and enclosed with vertical wood paneling. The changes include the addition of standard sized double-entry doors and three metal slider windows. There are three original window openings along this façade and four original double-hung wood windows and wood trim along the primary façade that appear to be in fair condition. The stepped parapet is constructed of wood and consists of an overhanging eave and decorative brackets. There is also a metal sign along the center of the primary façade that states "Purity Products Co." Although the stamp metal is original, the original painted signage that once showed Cerri Brothers, Rosenberg Brothers, and Del Monte has been painted over.

Photo showing the primary façade, facing north.

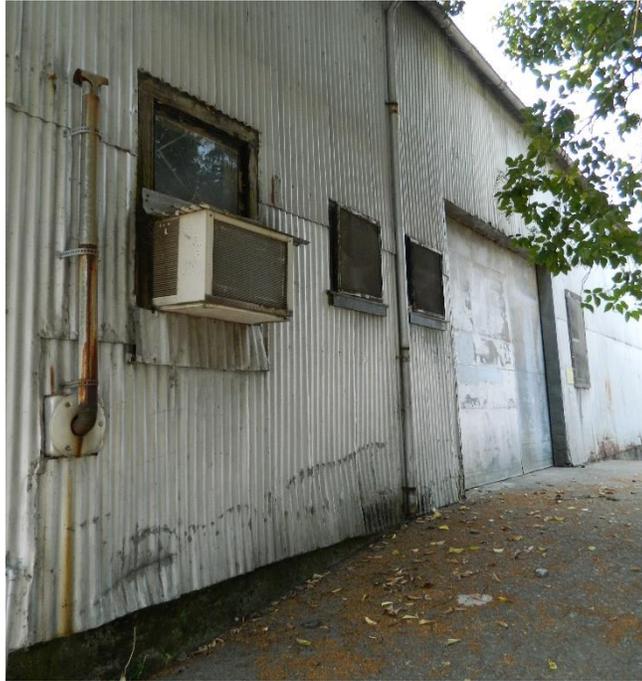
The east elevation is clad in corrugated sheet metal and two large entry bays with barn-style sliding doors that are clad in corrugated sheet metal. There are two doors, three double-hung wood windows, and two smaller windows that may be fixed, but are difficult to see. There is a shed addition that is clad in corrugated sheet metal with a metal roof and exposed rafters. There is a loading dock and ramp along this elevation and the parking lot is adjacent and east of the building. This east elevation is in fair to poor condition.

Photo showing the east elevation, facing north.

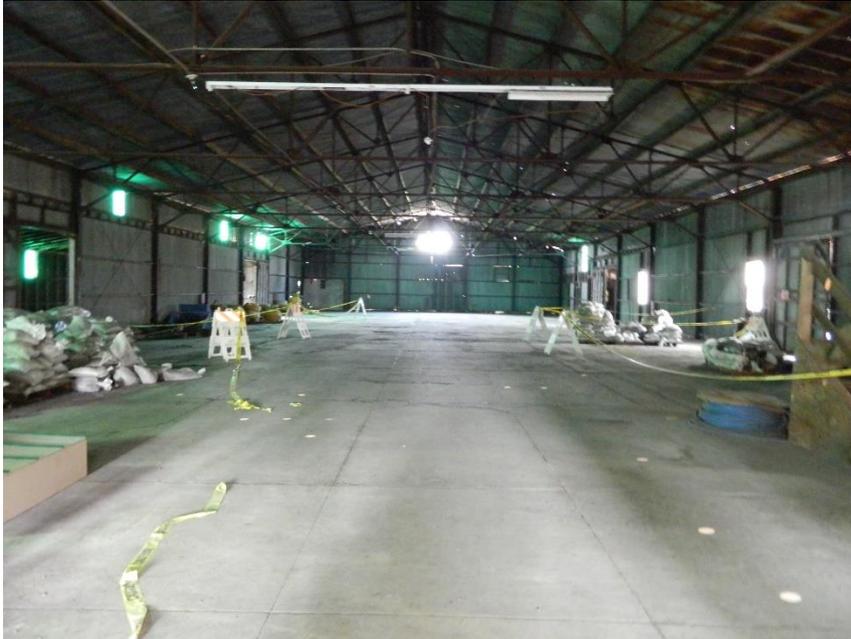
The interior has been modified since its use as a packing warehouse. The enclosed front “lobby” is not original and was likely added when the Purity Company owned the building. The area also various spaces within the front portion of the building have been reconfigured and are not original to the design of the building. There is also a mezzanine above the entry lobby that is accessible via stairs that are in poor condition. It is unclear if the mezzanine is original to the building, but was likely added later. The metal roof framing is exposed within the large open space of the interior where the fruit packing once took place. There are also concrete floors that appear to be original and are in fair condition.

Photo showing the interior of the building, facing north.
